DEPARTMENT OF TRANSPORTATION**DIVISION OF ENGINEERING SERVICES**

Quality Assurance and Source Inspection

Contract #: 04-0120F4Cty: SF/ALA Rte: 80 PM: 13.2/13.9File #: 69.28**WELDING INSPECTION REPORT****Resident Engineer:**Siegenthaler, Peter**Address:** 333 Burma Road**City:** Oakland, CA 94607**Report No:** WIR-019242**Date Inspected:** 13-Jan-2011**Project Name:** SAS Superstructure**OSM Arrival Time:** 700**Prime Contractor:** American Bridge/Fluor Enterprises, a JV**OSM Departure Time:** 1900**Contractor:** Zhenhua Port Machinery Company, Ltd (ZPMC), Changxing Island **Location:** Shanghai, China**CWI Name:** Liu Hua Jie**CWI Present:** Yes No**Inspected CWI report:** Yes No N/A**Rod Oven in Use:** Yes No N/A**Electrode to specification:** Yes No N/A**Weld Procedures Followed:** Yes No N/A**Qualified Welders:** Yes No N/A**Verified Joint Fit-up:** Yes No N/A**Approved Drawings:** Yes No N/A**Approved WPS:** Yes No N/A**Delayed / Cancelled:** Yes No N/A**Bridge No:** 34-0006**Component:** Orthotropic Box Girder(OBG)**Summary of Items Observed:**

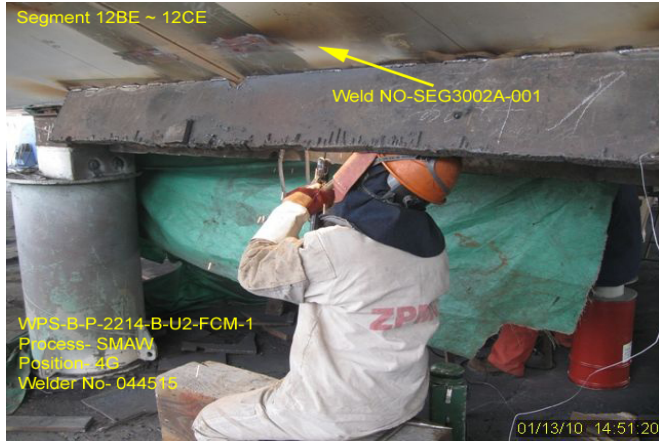
Segment 12BE

This QA Inspector observed ZPMC qualified welding personnel identified as 044515 perform Flux Core Arc Welding (FCAW), weld joint identified as SEG3002A-001; located On Orthotropic Box Girder (OBG) Bottom Plate to Side Plate CJP Weld; ZPMC Quality Control (QC) is identified as Mr. Liu Hua Jie. The welding variables recorded by QC appeared to comply with applicable WPS-B-P-2214-B-U2-FCM-1. See attached photo for further details.

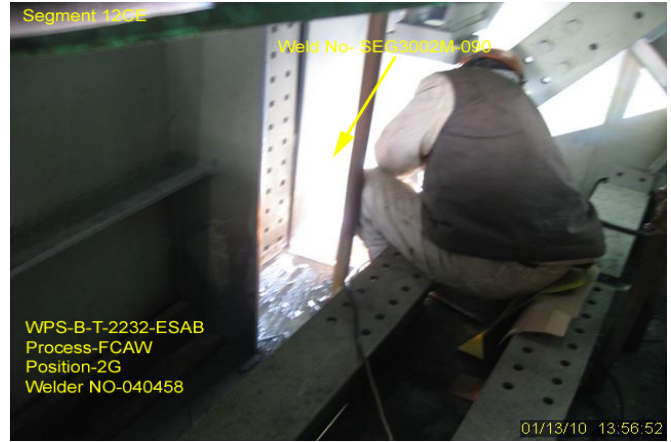
Segment 12CE

This QA Inspector observed ZPMC qualified welding personnel identified as 040458 perform Flux Core Arc Welding (FCAW), weld joint identified as SEG3002M-090; located On Orthotropic Box Girder (OBG) Bottom Plate to Longitudinal Diaphragm CJP Weld; ZPMC Quality Control (QC) is identified as Mr. Liu Hua Jie. The welding variables recorded by QC appeared to comply with applicable WPS-B-T-2232-ESAB. See attached photo for further details.
